### 2008-Efectis-R0425

# Effects of water mist on real large tunnel fires: Experimental determination of BLEVE-risk and tenability during growth and suppression

Project name Meting van BLEVE en leefbaarheid  
Project number 2007461

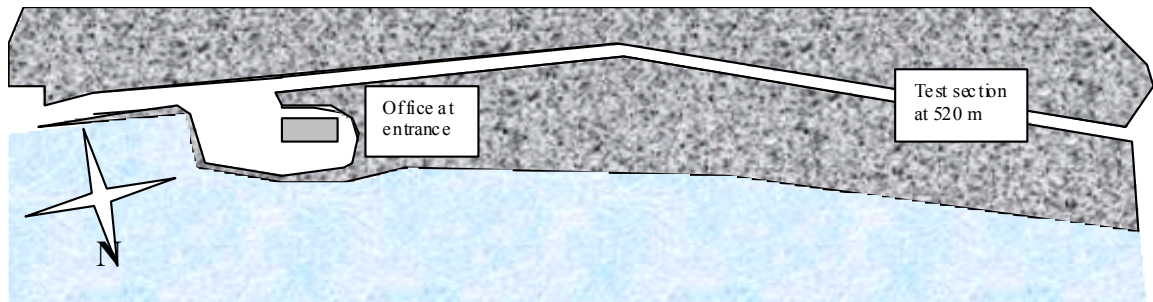
Figure 2.2. Overall lay-out. The total length of the tunnel is 1650 m.

All tests described were done in the Runehamar tunnel near Andalsnes in Norway. The location of the test site and entrance to the tunnel are shown in Figure 2.1. The overall layout and cross section of the tunnel with main dimensions are shown in Figure 2.2 and Figure 2.3.

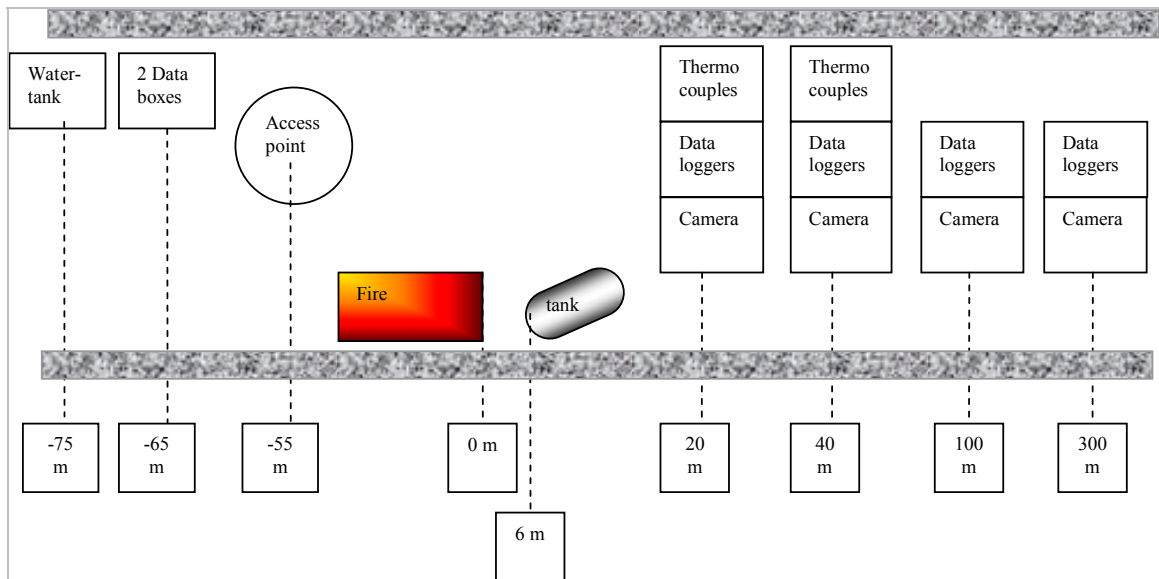
Figure 2.4. Main components of the Efectis network in the tunnel. Coordinates refer to the position along the length of the tunnel. The water tank provided cooling water through a 100 m long duct to the radiation sensors mounted on the tank. The data boxes contained a PC and two dataloggers each. Thermo-couple signals from the tank and from the positions at 20 m and 40 m travelled through underground cables to the data boxes. There they were digitized and logged, and transmitted by Ethernet to the access point. From there they were transmitted to the main building by glass fibre connection.

In order to evaluate tenability conditions, measurements of temperature, relative humidity, CO-concentration and vision distance were carried out at 4 locations shown in the Figure 2.4 .

The data acquisition system consisted of 2 Agilent HP-3970 data loggers, each placed in one data box. Each data logger was connected to a laptop (also in the box). See also Figure 2.4. All sensors belonging to section A, C, E were connected to one data logger and the remaining sensors to the other data logger. Data loss due to power failure was prevented with a UPS system in the box. The laptops were connected to the glass fiber Ethernet network in the tunnel and controlled via remote desk top

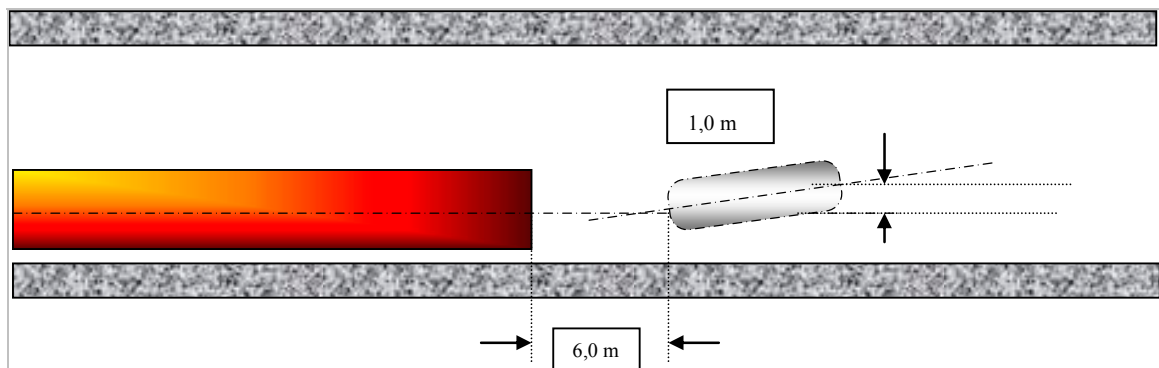
Figure 2.5. Location of the test-tank in relation to the fire load. Note: the figure shows the solid fire load on the right lane. The liquid fire load (diesel pool) was positioned in the middle of the tunnel, i.e. on both lanes.

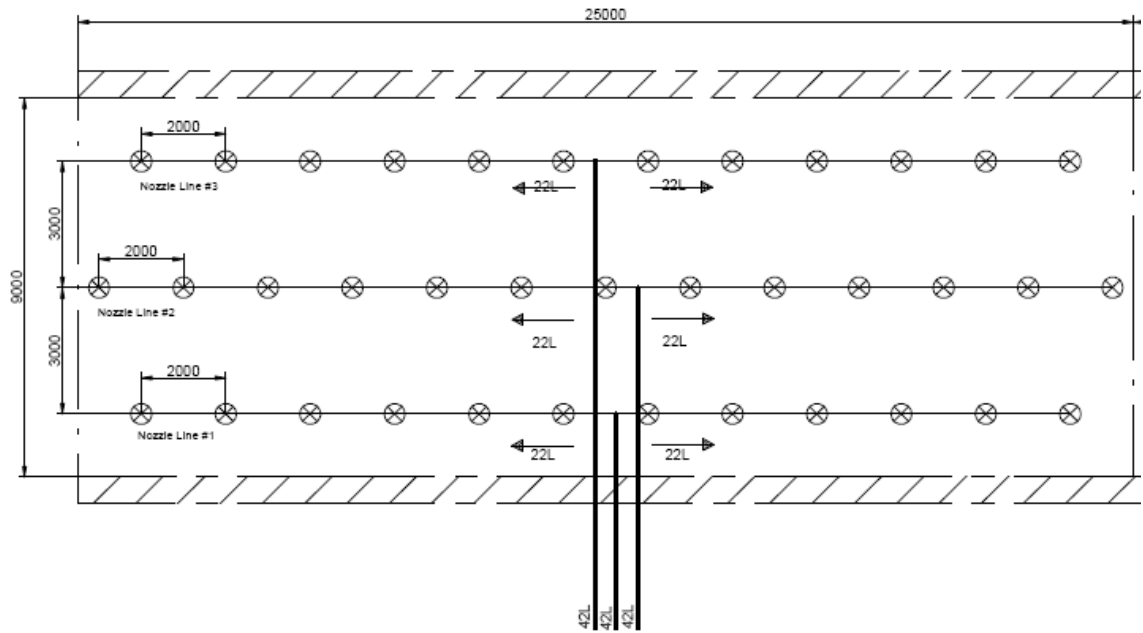
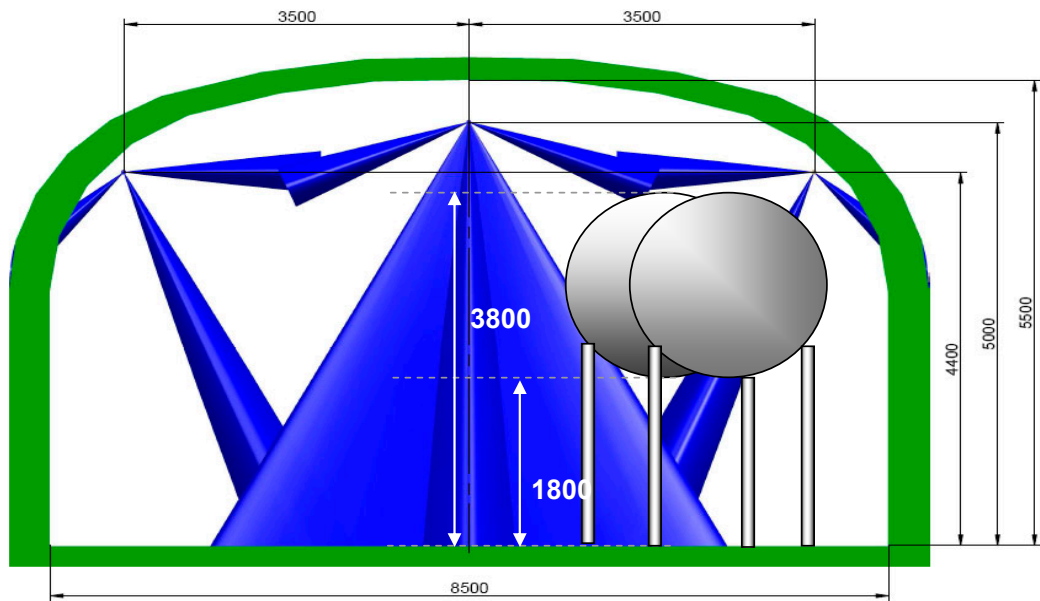
Figure 2.6. One of the three sections of the water mist-system in top view. Together, the sections are 75 m long, and run from - 50 m to + 25 m. Bottom: a cross-section of the tunnel showing the location of the nozzles and the intended spray pattern and the approximate position of the tank.

The water mist-system consisted of three sections as shown. Together the sections are 75m long and run from - 50 m to + 25 m.

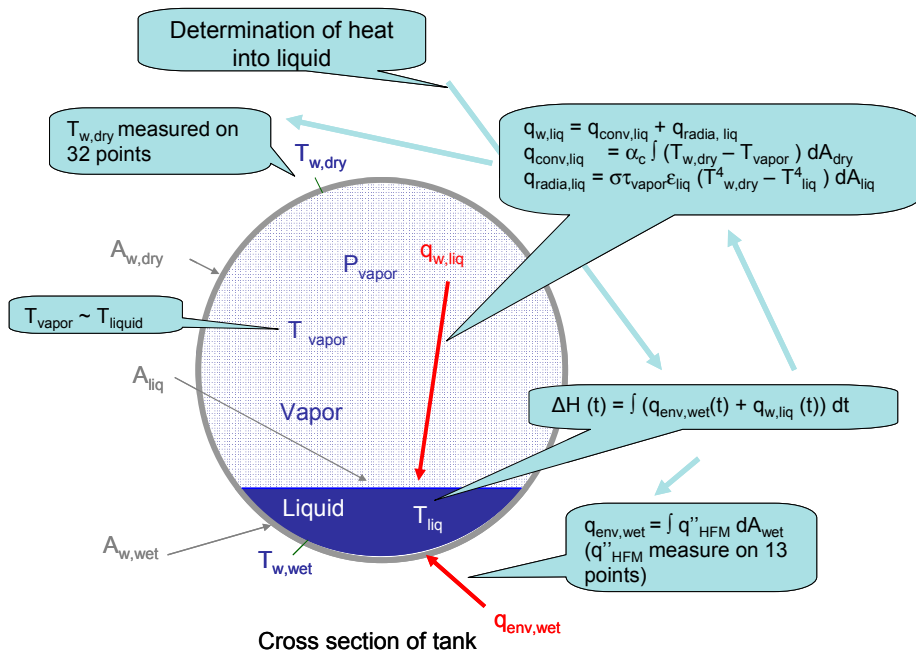
Figure 3.1 Determination of the heat fluxes into the liquid of the tank. Ref. [4].

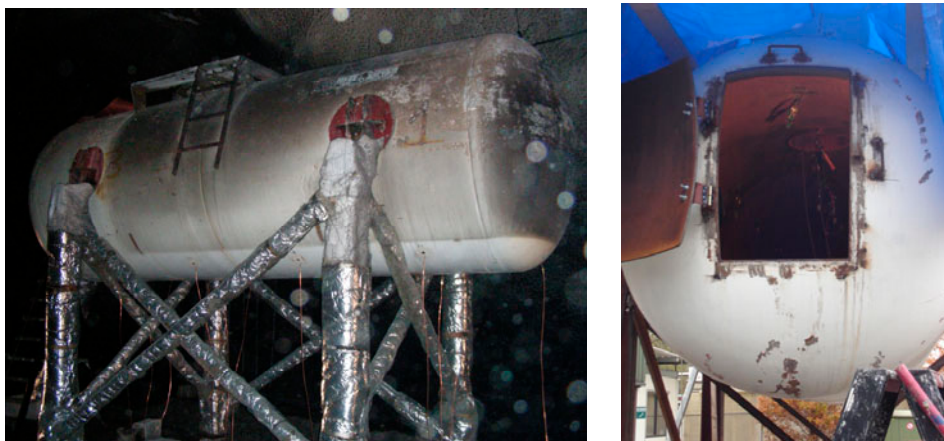
Figure 3.2 The test tank in the tunnel and the access door that was cut in the end wall. The supporting structure was designed and built to ensure that the top side of the test-tank was at 3.8 m above the road surface, similar to the height assumed in the Solico-model. The picture at the left shows the structure wrapped in protection against heat, after the first verification test.

The test tank consisted of a full-size LPG-tank, filled with water for 5% of its volume. The tank is shown in Figure 3.2.

For practical reasons the test-tank (length 6m, diameter 2.2m) was smaller than the reference tank (length 12.0m, diameter 2.5m). The smaller diameter of the test-tank corresponds well with the fact that the test-tunnel has a somewhat smaller cross-section than the reference tunnel. The shorter length of the test-tank will cause a quicker rise in LPG temperature and thus a higher probability of a BLEVE. The wall thickness is 8.8 mm as compared to 10 mm for the reference tank. This will lead to somewhat higher wall temperatures and is an acceptable conservative approach. The thermal properties of the steel are equivalent to those in the reference tank studied in Ref. [1] and [2].

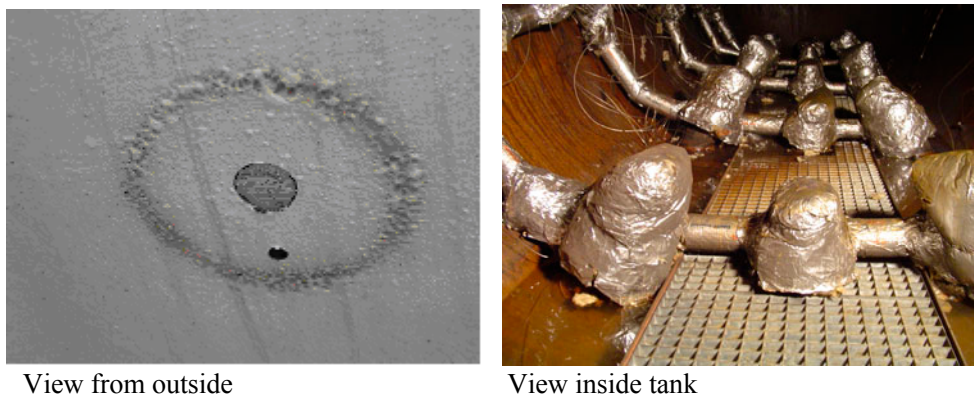
Figure 3.3 Mounting of heat flux-sensor in the tank wall and insulation of the water cooling inside the tank.

Heat flux-sensors were installed in holes that were drilled in the lower tank wall. The receiving surface of the sensors was carefully mounted exactly flush with the outer tank wall with a clearance of less than 0.2 mm. The heat-flux sensors were cooled by water supplied from a main hose outside the tank. The main hose was connected to smaller copper tubes inside the tank leading to the heat flux-sensors. The tubes were insulated with mineral wool to prevent heating up of the cooling water. The cooling water was discharged via copper tubes mounted through the ‘belly’ of the tank. See Figure 3.3. Technical information about the heat flux-sensors used is given in Appendix A.

The heat flux-sensors measure the heat flux into the ‘wetted’ part of the tank without taking into account the ‘heat resistance’ of the water layer inside the tank. This is closer to the real situation, because the ‘heat resistance’ of the LPG liquid in the reference tank will be less than the ‘heat resistance’ of the water layer in the test tank. The measured heat fluxes will be somewhat higher than in reality. This is an acceptable conservative approach. See also Ref.[4].

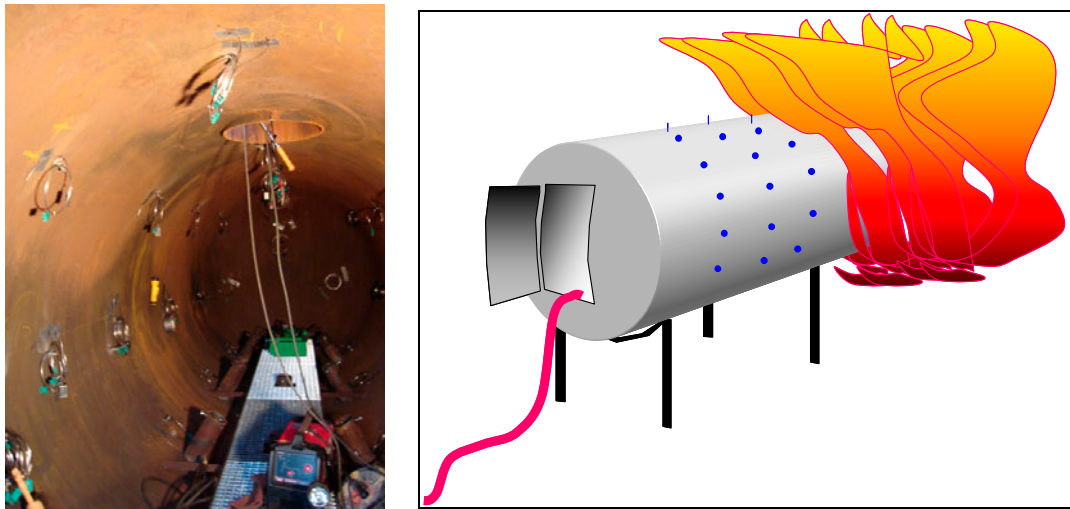
Figure 3.4 Interior of the tank during installation of thermocouples and configuration during a test.

The instrumentation of the test tank was completed, connected to the data acquisition system and fully tested at the site of Efectis NL. See also Figure 3.4.

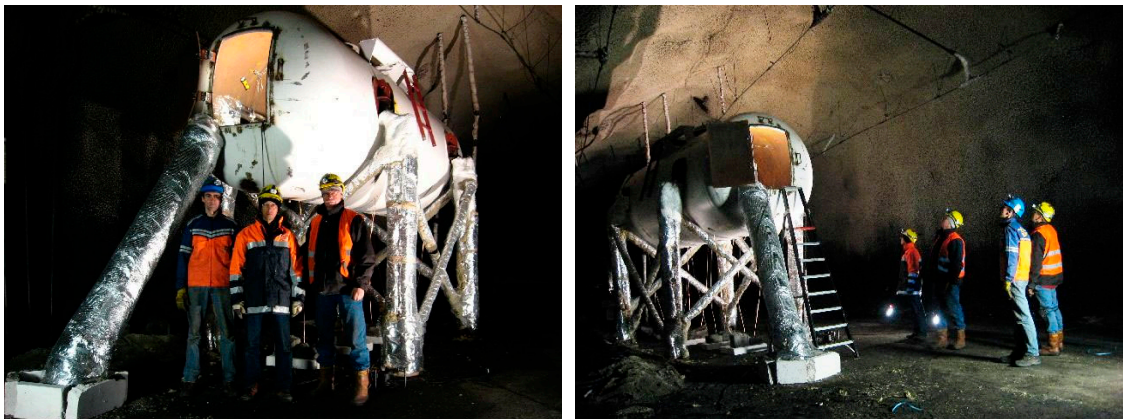
Figure 3.5 The actual test-tank after completing the installation in the Runehamar tunnel

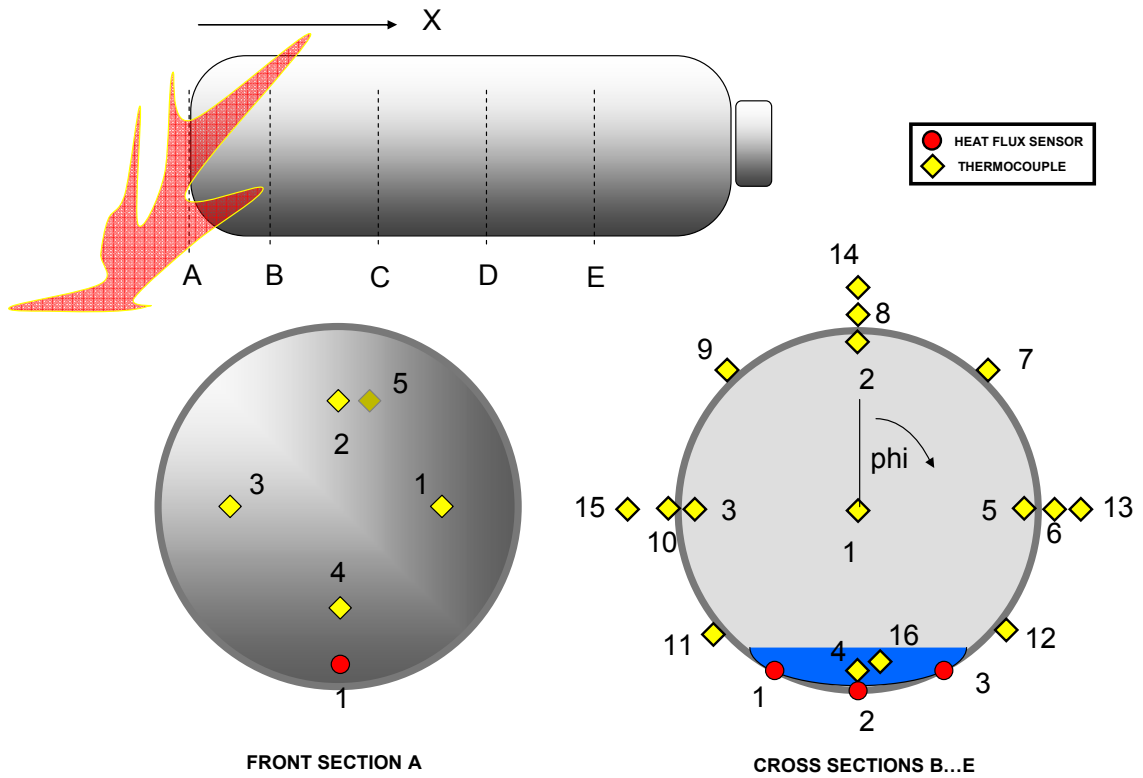
Figure 3.6 Lay out and labelling of heat flux sensors and thermocouples. In this figure the right side of the tank (labels 6, 13 e.g.) is facing the right wall of the tunnel and the left side of the tank (labels 10, 15 e.g.) is facing the middle of the tunnel.

The planned lay-out and labeling of the heat flux sensors and thermocouples is shown in Figure 3.6.

The actual layout of the sensors was slightly different due to the presence of the connections to the mounting frame and the manhole. The actual positions are shown in Table 3.1 in polar coordinates.

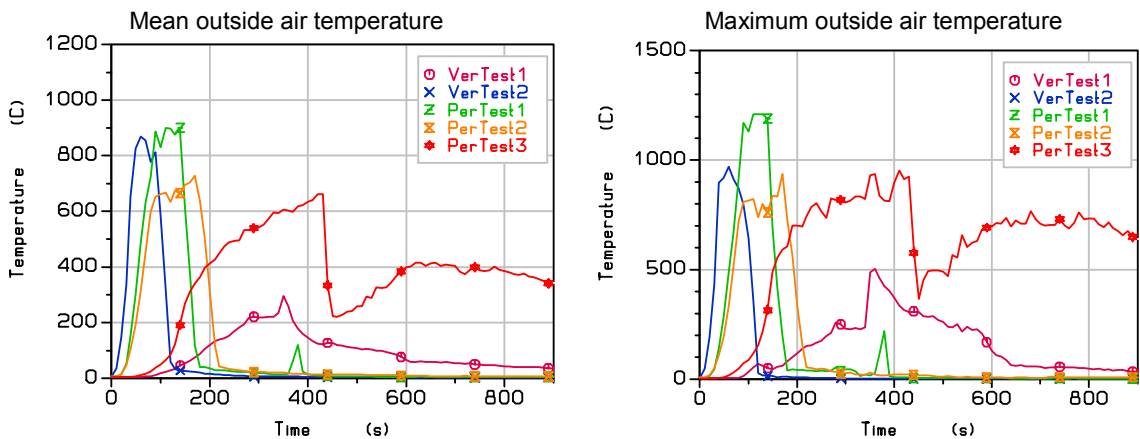
Figure 3.12 Mean and maximum temperature of the air surrounding the test tank

Measured temperatures near the outer surface of the tank (0.10 m from the tank shell) are shown in Figure 3.12. The graph left shows the average of the 12 air temperatures measured over a period of 900 s after ignition of the fire. The sharp decrease of the air temperature is caused by the switching on of the water mist system. In the pool fire tests (VerTest2 and PerTest1 & 2) the fire was extinguished or significantly reduced within 60 s by the water mist, resulting in a temperature drop below 40 °C. In the tests with the solid fire (VerTest1 and PerTest3) the fire was not extinguished but controlled by the system. In PerTest3, seeking the limits of the system, the mean air temperature stayed around 400 °C (after an initial drop to 220 °C) and the maximum air temperature around 700 °C (after an initial drop to 400 °C).

The position of the maximum temperature depended on the fire source as explained below.

Firstly, in the pool fire tests the (left) side of the tank facing the middle of the tunnel was exposed to higher temperatures than the other (right) side. This was partly caused by the symmetric position of the pool in the tunnel in contrast to the non-symmetric position (on the right lane) of the tank and partly by the non-parallel position of the tank with respect to the tunnel walls. In the solid fire tests the thermal exposure of the tank sides was more symmetrically, due to the fact that both the tank and fire source were positioned on the right lane.

Finally, in the pool fire tests the exposure to the highest temperatures was more towards the end of the tank (Section D and E) whereas in the solid fire tests this maximum was more at the beginning (Section A and B). This difference was most probably caused by the different distances between the base of the fire and the tank. In the pool fire the minimum distance to the tank was almost immediately attained due to the fast spread of the fire over the total fuel bed. With the solid fire the initial distance was larger, because of the more slowly fire spread from the rear of the pallet pile (where the fire was ignited) to the front (facing the tank) of the pile. See also Ref. [3].

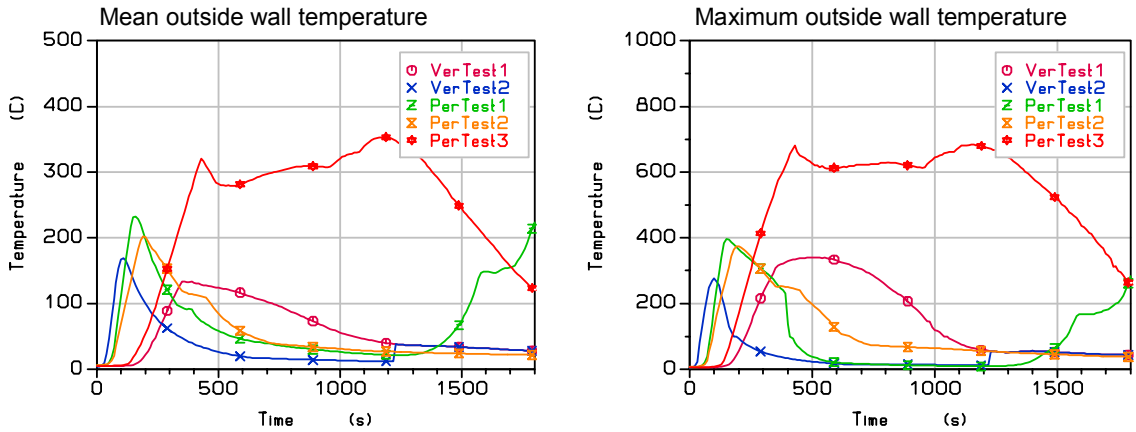
Figure 3.13 Mean and maximum temperature of the outside surface of the tank shell. Note: the increase of temperature in PerTest 1 is caused by the after burning of the fuel and is not a part of the official test.

The maximum temperature of the tank wall is shown in Figure 3.13 for each test, but now for a period of 1800s. The maximum wall temperatures were in the same area as the maximum air temperatures around the tank. Clearly the wall temperatures follow the surrounding air temperatures, but with a time delay caused by the thermal inertia of the wall. The highest temperature (about 600°C) occurred in the solid fire test “PerTest3” where the fire was only to a certain extent controlled by the water mist system.

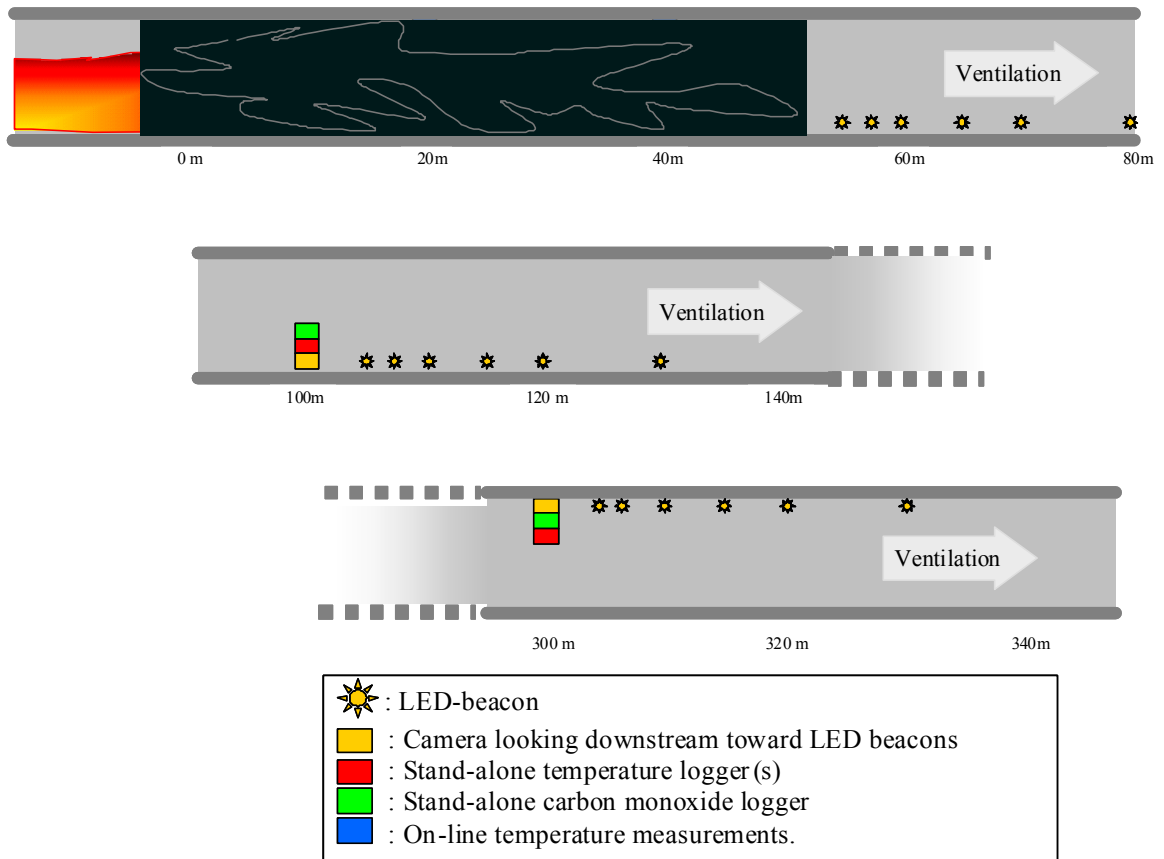
Figure 4.1. Location of main components of the tenability-measurements. The figures below each length represent de length-coordinate along the tunnel in m. Note: Contrary to convention, North is in the downward direction in this schematic drawing..

At 20 m, on the south side of the tunnel, a set of two thermocouples (at heights of 0.6 m and 1.6 m) and one plate-thermocouple (at a height of 1.6 m) was installed. The plate thermocouple was installed facing the fire load and tilted 45 degrees backward to receive radiation also from the hot smoke near the ceiling. The sensors were connected to the on-line measurement network. At 20 m, on the north side of the tunnel, a semiconductor sensor was installed. This was a stand-alone data logger that measured both temperature and relative humidity. Also on the north side, a stand-alone data logger was installed that measured the concentration of carbon monoxide. Again, on the north side, a stand-alone camera was installed at a height of 0.6 m that looked downstream towards a line of six beacons with LED-lamps. The beacons were also installed along the north edge of the road surface, and mounted at distances from the camera of 5, 7, 10, 15, 20 and 30 m.

At 50 m, on the north side of the tunnel, a semiconductor sensor was installed at a height of 0.6 m. This was a stand-alone data logger that measured both temperature and relative humidity. Also on the north side, a stand-alone data logger was installed at a height of 0.6 m that measured the concentration of carbon monoxide. Again, on the north side, a stand-alone camera was installed at a height of 0.6 m that looked downstream towards a line of six beacons with LED-lamps. The beacons were also installed along the north edge of the road surface, and mounted at distances from the camera of 5, 7, 10, 15, 20 and 30 m respectively.

At 100 m, on the north side of the tunnel, the following sensors were installed: A CO-logger at 1.2 m height, and temperature/relative humidity loggers at 0.6 m and 1.6 m height. On the north side, a stand-alone camera was installed at a height of 0.6 m that looked downstream towards a line of six beacons with LED-lamps. The beacons were also installed along the north edge of the road surface, and mounted at distances from the camera of 5, 7, 10, 15, 20 and 30 m respectively.

At 300 m, on the south side of the tunnel, a temperature/relative humidity logger, a CO-logger and a camera and associated beacons were installed. At 300 m the sensors were installed at the south side rather than the north side because all transport to NBL installations further downstream used a track on the north side, and it was considered safer for the equipment to be installed away from the traffic. Due to the long distance from the fire, it is virtually certain that there was no significant difference between conditions on both sides.

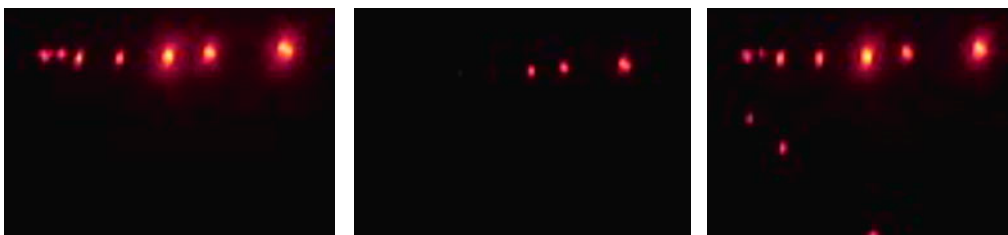
Stills from the video that were used to determine visibility. From left to right: before, during and after the test. Note the reflection of the beacons in the flooded road surface after the test.

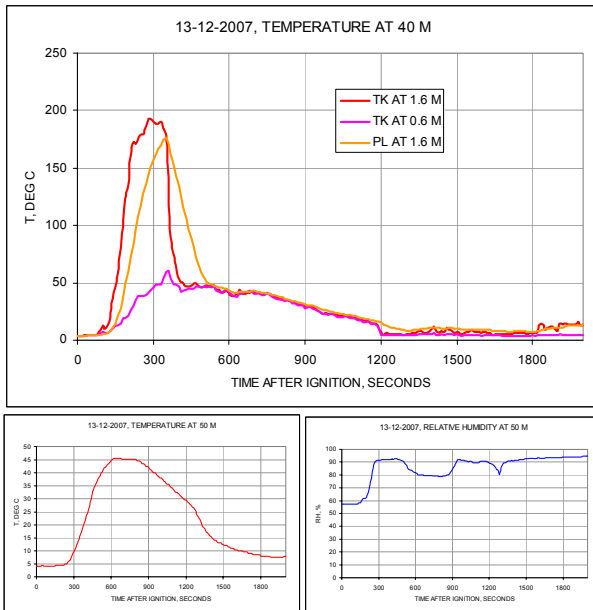
Figure 4.3 Top: temperatures measured on-line with thermocouples. Bottom: temperature and relative humidity measured at 0.6 m height with stand-alone semiconductor sensor. The temperature readings are discussed in 4.8.1

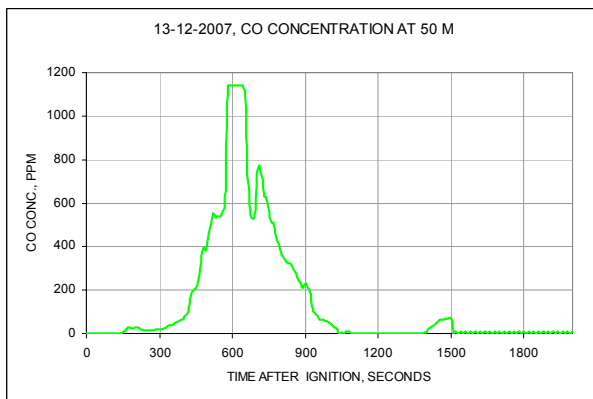
Figure 4.4 CO concentration measured at 0.6 m height with stand-alone semiconductor sensor.

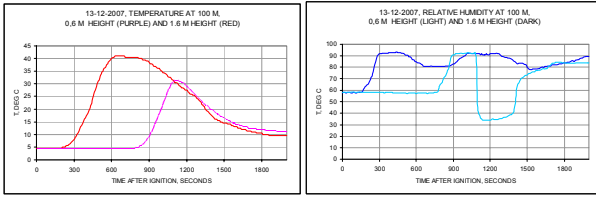
Figure 4.6 Temperatures and relative humidities measured with semiconductor sensors.

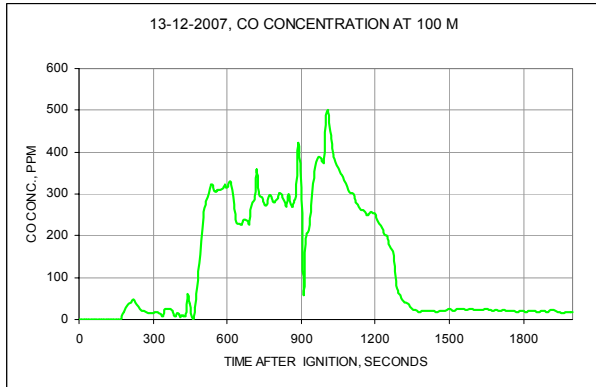
Figure 4.7 CO concentration

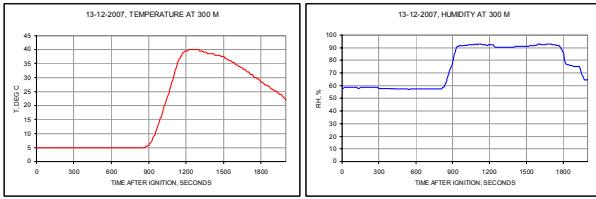
Figure 4.9 Temperature and relative humidity measured at 0.6 m height with semiconductor sensor. The temperature readings are discussed in 4.8.1

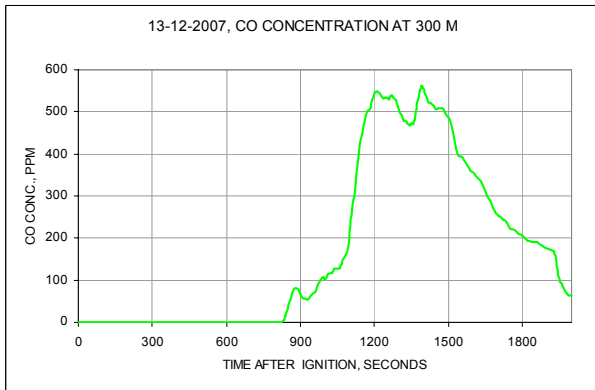
Figure 4.10 CO concentration

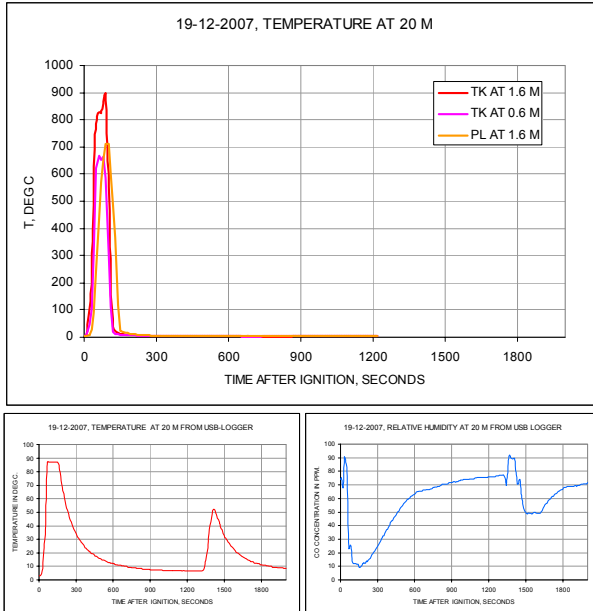
Figure 4.12 Top: temperatures measured with thermocouples. Bottom: temperature and relative humidity measured at 0.6 m height with semiconductor sensor. The temperature readings are discussed in 4.8.1

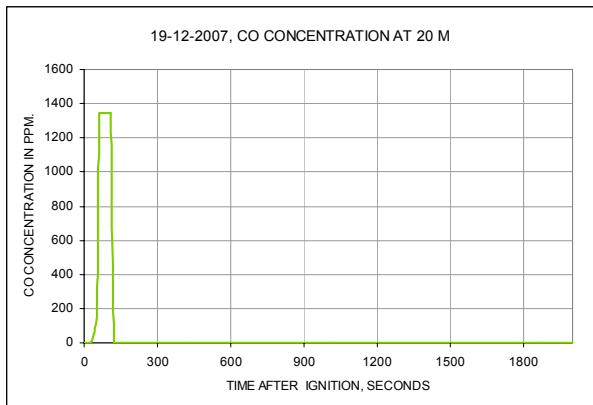
Figure 4.13 CO concentration measured with semiconductor sensor at 0.6 m

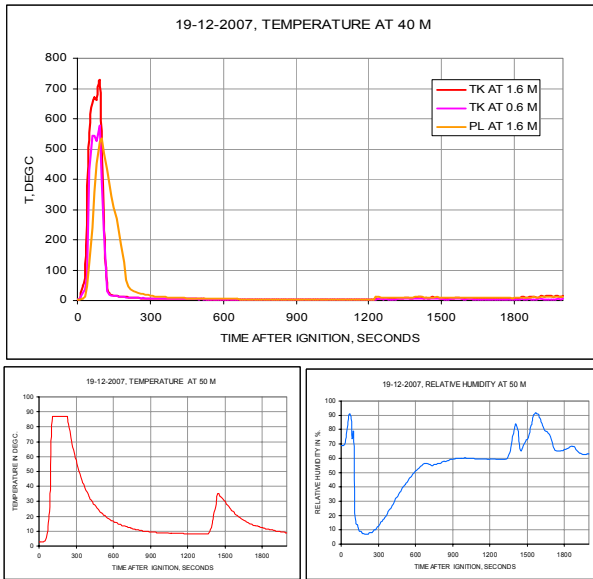
Figure 4.14 Top: temperatures measured with thermocouples. Bottom: temperature and relative humidity measured at 0.6 m height with semiconductor sensor. The temperature readings are discussed in 4.8.1

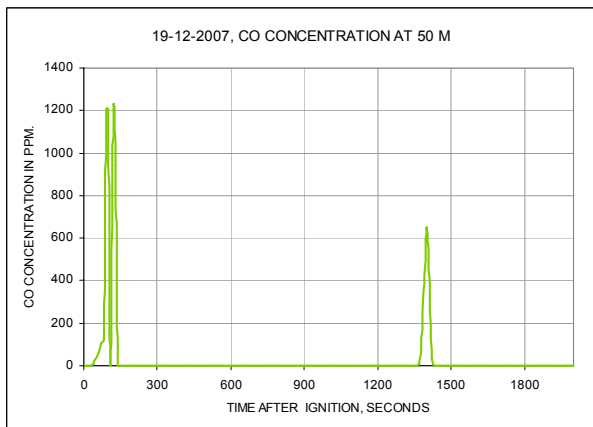
Figure 4.15 CO concentration measured with semiconductor sensor at 0.6 m

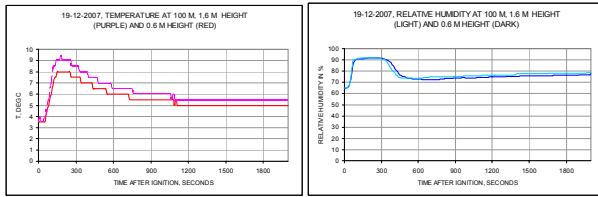
Figure 4.17 Temperatures and relative humidities, measured with semiconductor sensors at 1.2 m height. The temperature rise is very small, and is recorded by both sensors. It is also consistent with the readings at 300 m.

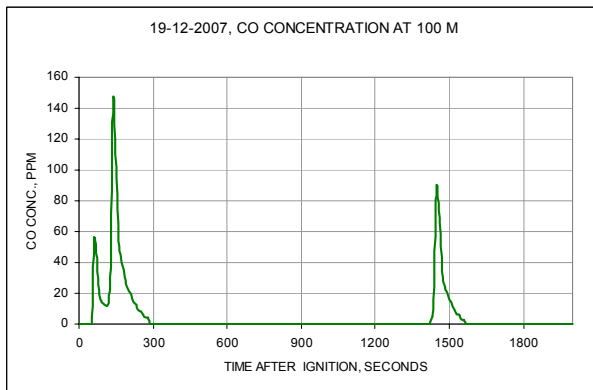
Figure 4.18 CO concentration measured with semiconductor sensors at 1.2 m

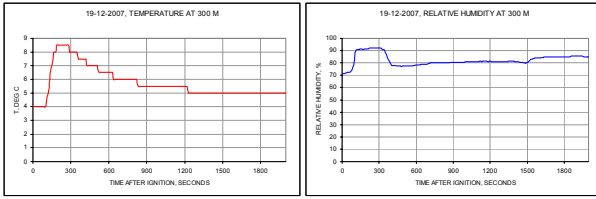
Figure 4.20 Temperatures and relative humidities, measured with semiconductor sensors at 1.2 m height.

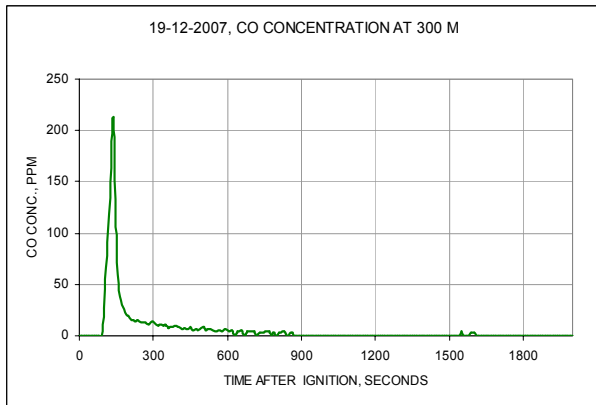
Figure 4.21 CO concentration measured with semiconductor sensors at 1.2 m

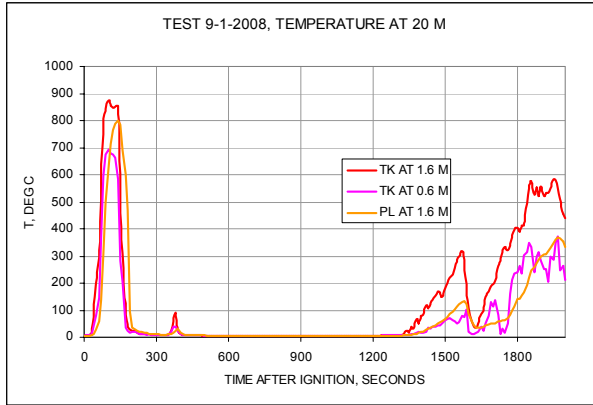
Figure 4.23. Temperatures measured with thermocouples. The rise after 1300 s. is caused by burning-off of excess fuel.

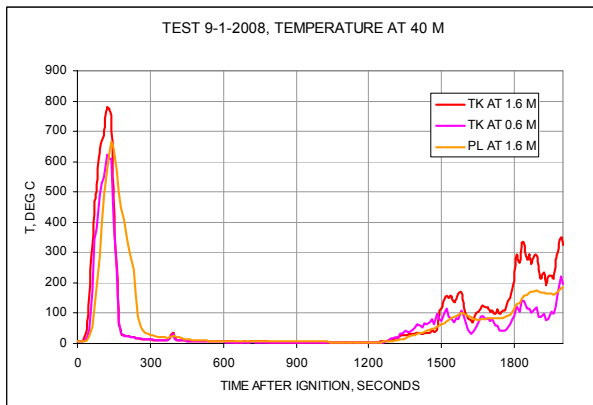
Figure 4.24 Temperatures measured with thermocouples

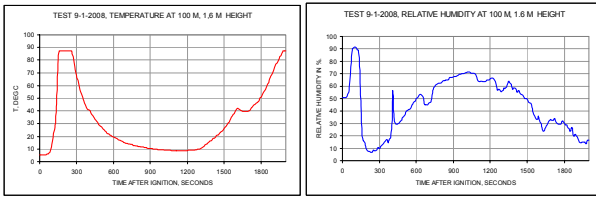
Figure 4.25 Temperature and relative humidity, measured with semiconductor sensors at 1.2 m height

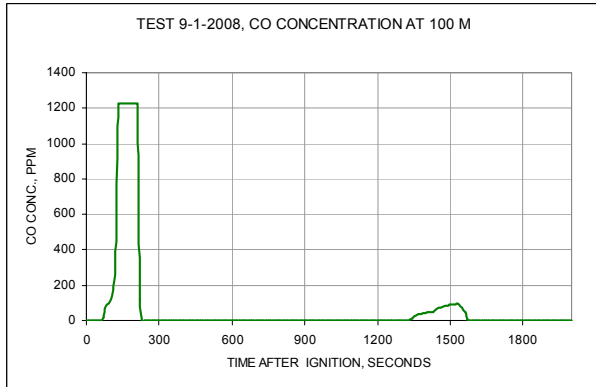
Figure 4.26 CO concentration, measured with semiconductor sensors at 1.2 m height

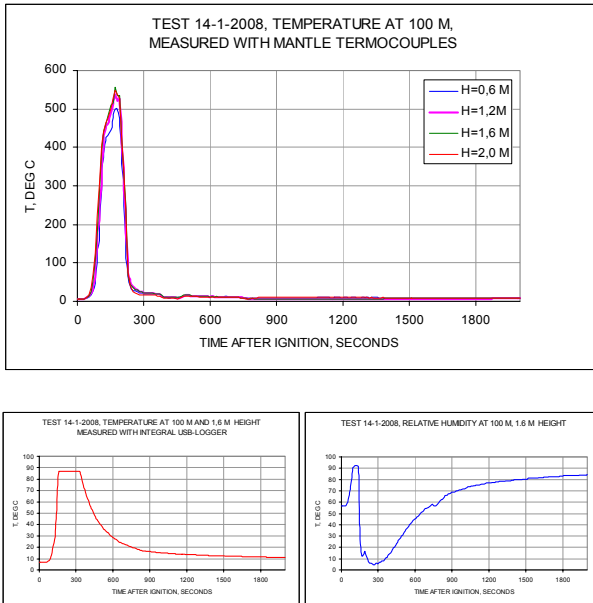
Figure 4.34 Top: temperatures measured with thermocouples. Bottom: temperature and relative humidity measured with semiconductor sensors at 1.2 m height.

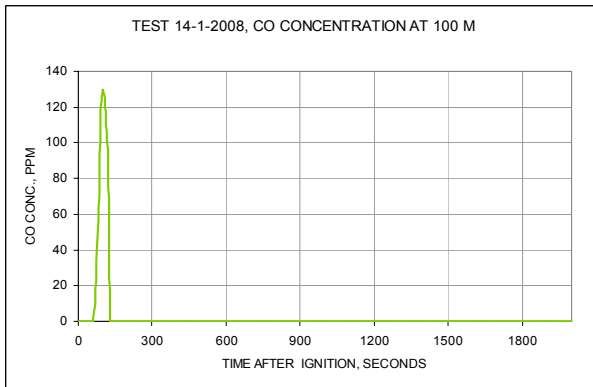
Figure 4.35 CO concentration measured with semiconductor sensor at 1.2 m height.

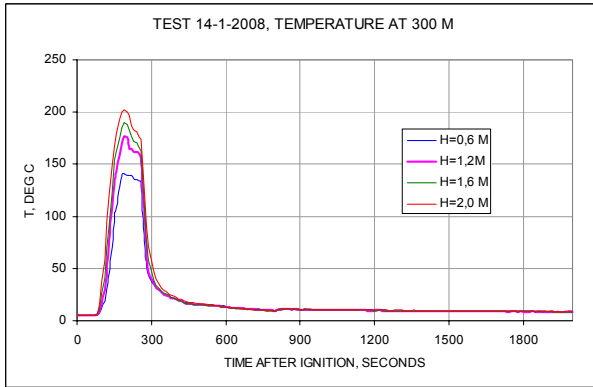
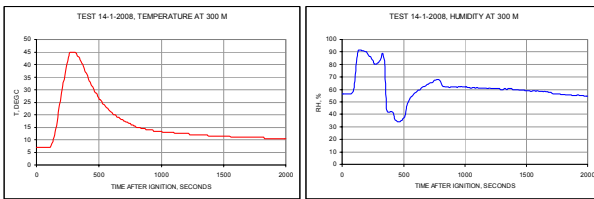
Figure 4.37 Top: temperatures measured with thermocouples. Bottom: temperature and relative humidity measured with semiconductor sensors at 1.2 m height.

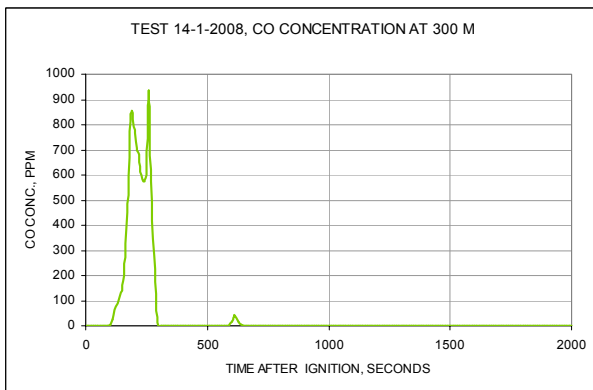
Figure 4.38 CO concentration measured with semiconductor sensor at 1.2 m height.

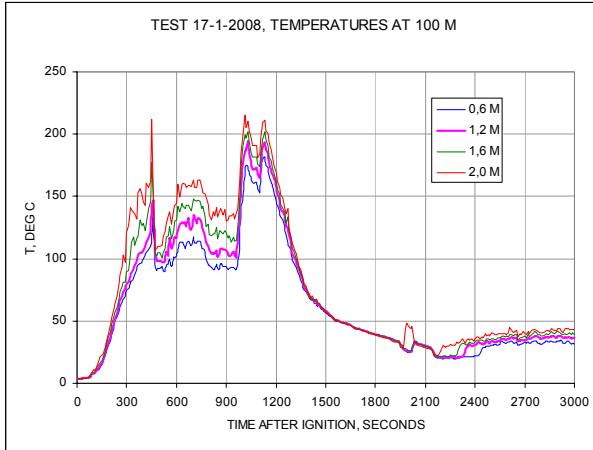
Figure 4.43 Temperatures measured with thermocouples

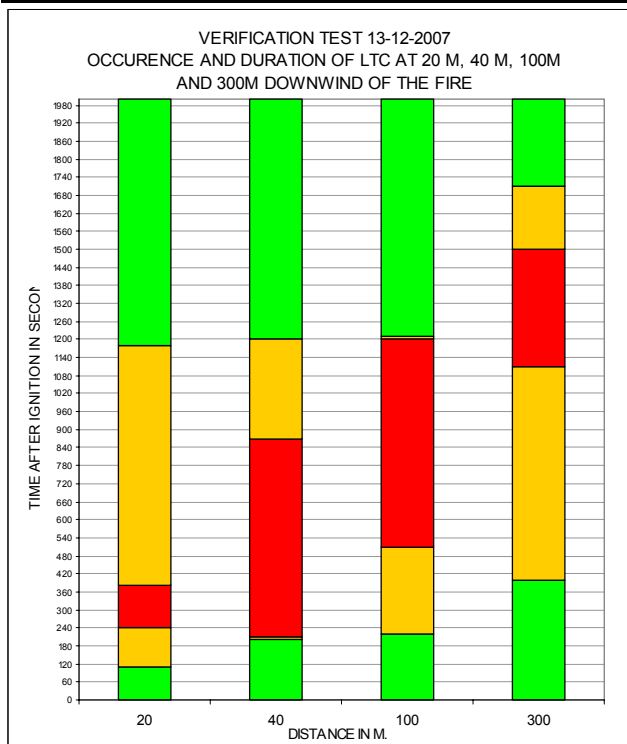
VERIFICATION TEST 13-12-2007				
Occurrence and timing life-threatening conditions (LTC)				at
20 m, 40 m, 100m and 300 m downwind of the fire.				
Distance from fire	20	40	100	300
Moderate danger starts ...s after ignition	110	200	220	400
Acute danger starts ...s after ignition	240	210	510	1110
Acute danger ends ...s after ignition	380	870	1200	1500
Moderate danger ends ...s after ignition	1180	1200	1210	1710

Figure 4.49. The water mist system was activated 335 s after ignition.

- Both carbon monoxide and high temperature are significant threats, and the long duration of poor visibility (initially caused by smoke and later on by clouds of water droplets) worsens the effects of the two primary factors.

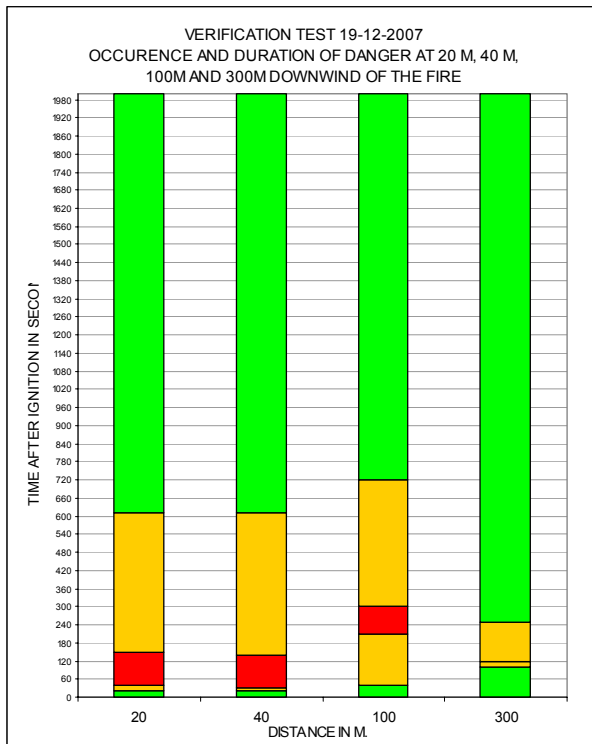
VERIFICATION TEST 19-12-2007				
Occurrence and timing life-threatening conditions (LTC) at m, 40 m, 100m and 300 m downwind of the fire.				20
Distance from fire	20	40	100	300
Moderate danger starts ...s after ignition	20	20	40	100
Acute danger starts ...s after ignition	40	30	211	120
Acute danger ends ...s after ignition	150	140	300	120
Moderate danger ends ...s after ignition	610	610	721	247

Figure 4.50 The water mist system was activated 96 s after ignition.

- At 20 m and at 40-50 m the peak in temperatures (up to 600 deg C) coincided with the peak in CO-levels during 0 to 2.5 minutes. Visibility remained poor for about 5 minutes.
- At 100m and at 300 m, the carbon monoxide concentration remained at safe levels. No reliable temperature data are available at 100 m or at 300 m. Extrapolating from the temperatures at 40 m, it is likely that these will have led to condition “yellow” at 100 m at least. Combined with the poor visibility during the first 4 minutes, this leads to the conditions as shown in the figure.

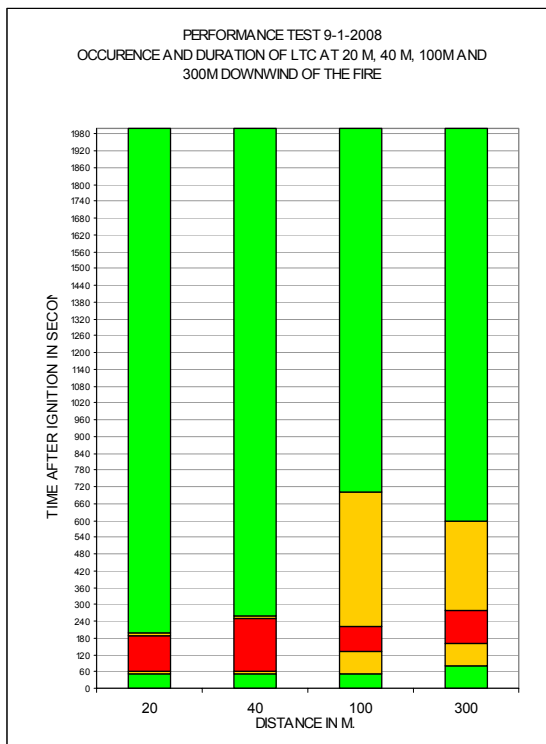
PERFORMANCE TEST 9-1-2008				
Occurrence and timing life-threatening conditions (LTC) at 20 m, 40 m, 100m and 300 m downwind of the fire.				
Distance from fire	20	40	100	300
Moderate danger starts ...s after ignition	50	50	50	80
Acute danger starts ...s after ignition	60	60	130	160
Acute danger ends ...s after ignition	190	250	220	280
Moderate danger ends ...s after ignition	200	260	700	600

Figure 4.51 The water mist system was activated 125 s after ignition.

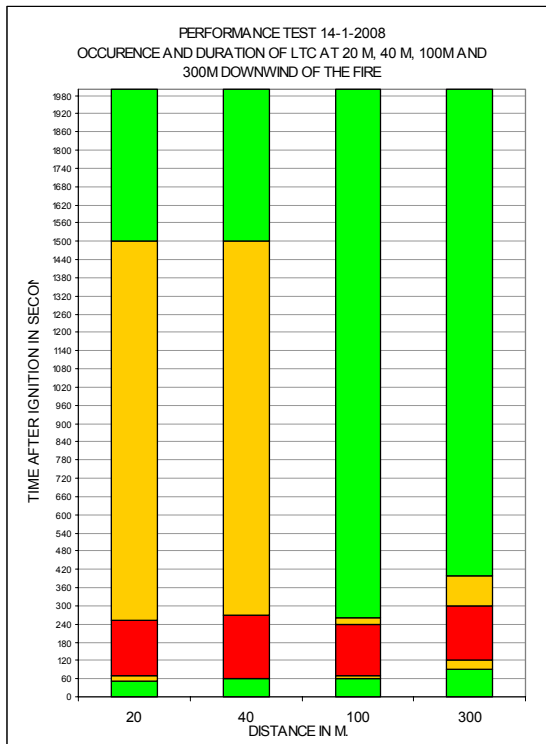
PERFORMANCE TEST 14-1-2008				
Occurrence and timing life-threatening conditions (LTC) at 20 m, 40 m, 100m and 300 m downwind of the fire.				
Distance from fire	20	40	100	300
Moderate danger starts ...s after ignition	50	60	60	90
Acute danger starts ...s after ignition	70	60	70	120
Acute danger ends ...s after ignition	250	270	240	300
Moderate danger ends ...s after ignition	1500	1500	260	400

Figure 4.52 The water mist system was activated 160 s after ignition.

The duration of the threat runs from 1 to about 5 minutes. The “red “periods are, if anything, longer than during the test on 9 January 2008, indicating that using water with a biodegradable AFFF seems certainly not more effective in controlling and suppressing the fire than using pure water.

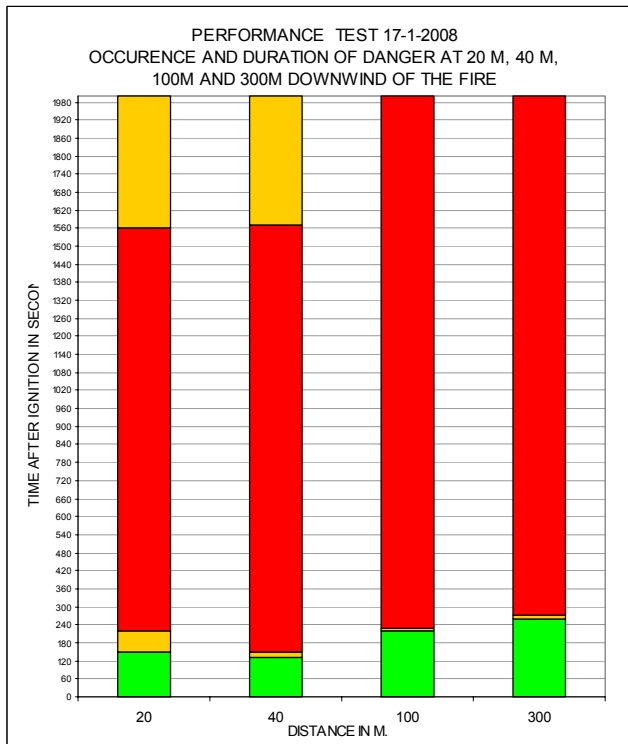
PERFORMANCE TEST 17-1-2008				
Occurrence and timing life-threatening conditions (LTC) at 20 m, 40 m, 100m and 300 m downwind of the fire.				
Distance from fire	20	40	100	300
Moderate danger starts ...s after ignition	150	130	220	260
Acute danger starts ...s after ignition	220	150	230	270
Acute danger ends ...s after ignition	1560	1570	2000	2000
Moderate danger ends at ...s after ignition	2000	2000	2000	2000

Figure 4.53 The water mist system was activated 439 s after ignition.

- At 20 m, the temperature rose to lethal levels between 3 min and 22 min after ignition.
- At 40-50 m, conditions and times were similar. Visibility was poor for about 35 minutes after ignition.
- At 100m, high temperatures lasted until 22 minutes, but lethal CO concentrations and poor visibility persisted until 35 minutes. Similar conditions were found at 300 m.

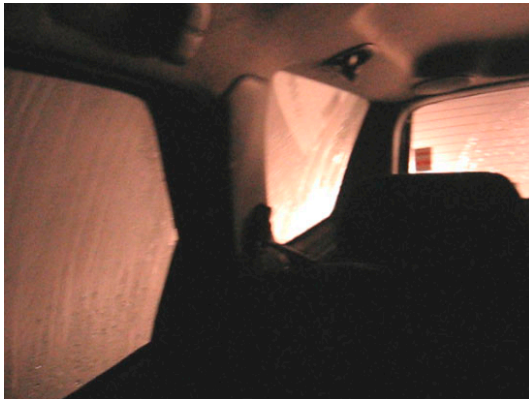
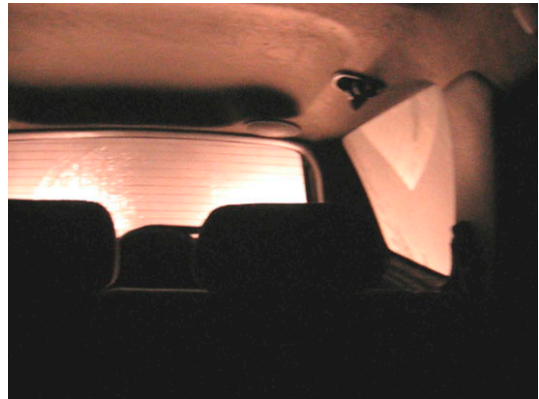
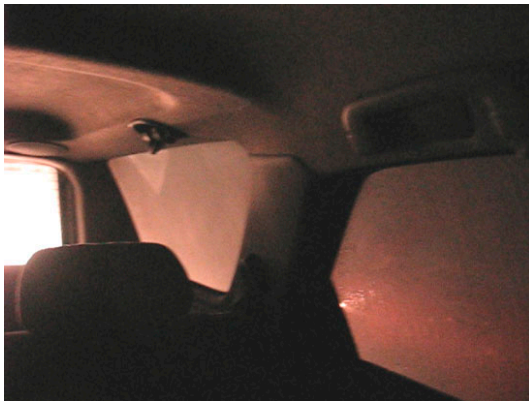
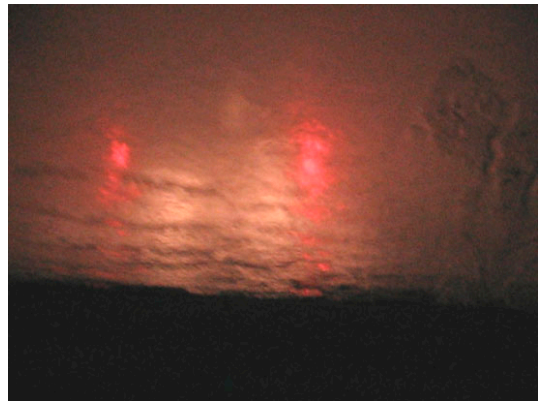
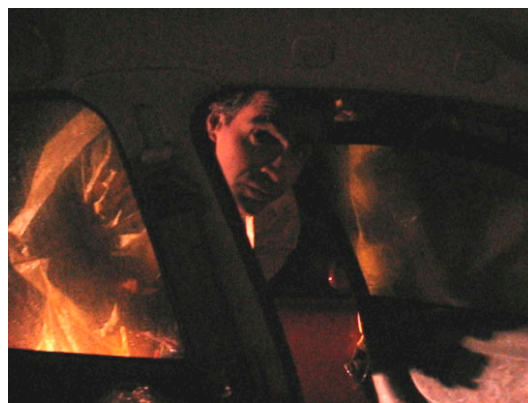
Five stills from the video taken inside the car during the test. Visibility is generally poor (at most a few metres), but the rear lights of the car in front, about 5 m away, are clearly visible.

The reports from the pedestrians show that the intensity of the water mist system can be compared to a very heavy tropical downpour, and that visibility of objects that do not emit light themselves was very poor under the test-conditions. However, the headlights, rear lights and the LED beacon were visible from a distance. The table below shows the results.

Source	Visible from ... m away
Dipped headlight	29
Rear light	19
LED beacon	19
